City of Corpus Christi
Water Distribution System

Potential Backflow Incident

Progress on Backflow Incident

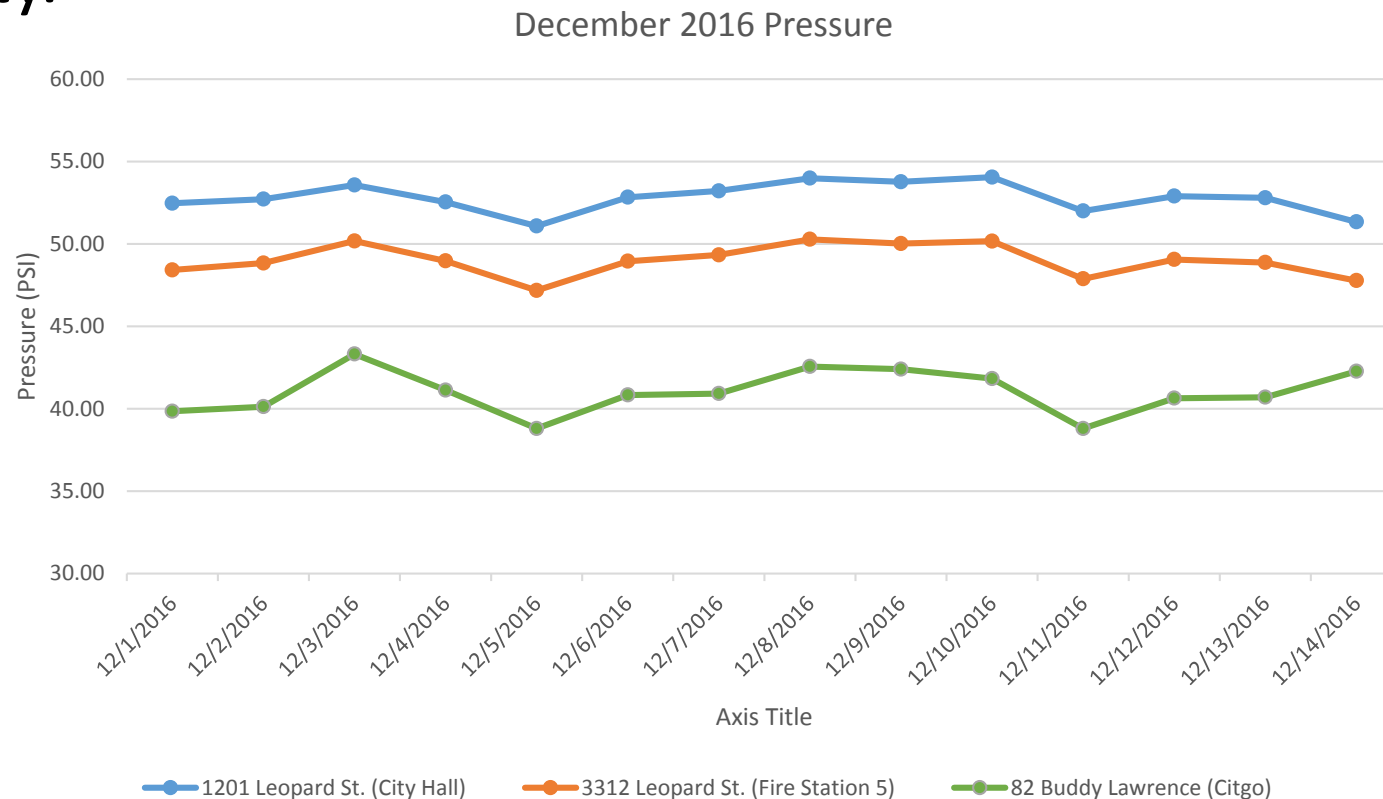
- Currently gathering Supervisory Control And Data Acquisition data for pressure Pounds per Square Inch (PSI) for the following locations: Citgo, Fire Station #5, and City Hall.
- Goal is to show that Citgo always has a lower PSI compared to the other two so the water would not flow from Citgo area to other parts of the City.
